Mooring Ropes Inspection and Retirement Guidelines – Timm Acera daGama

3. Rope condition evaluation

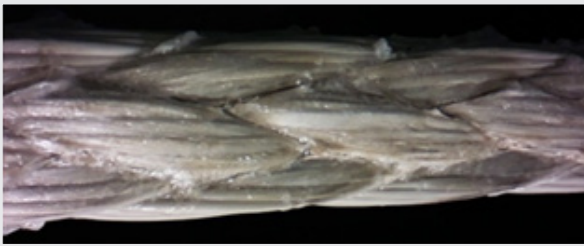
Fibers intact, no visible external damage.

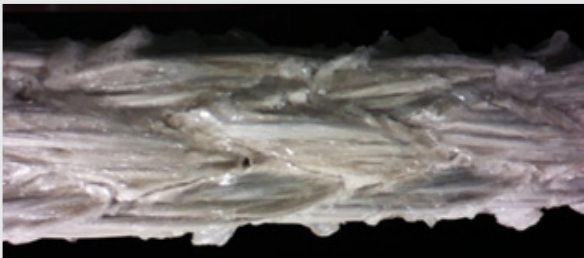
Visible abrasion localized where rope has been in contact with uneven surface. Recommend monitoring the rope, inspect and if needed repair the hardware and protect the rope.

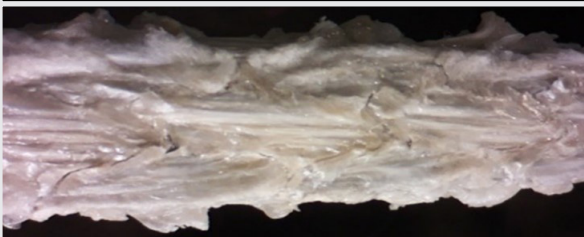
Abrasion clearly visible on more than 10% of the cross section of the rope. Rope must be retired.

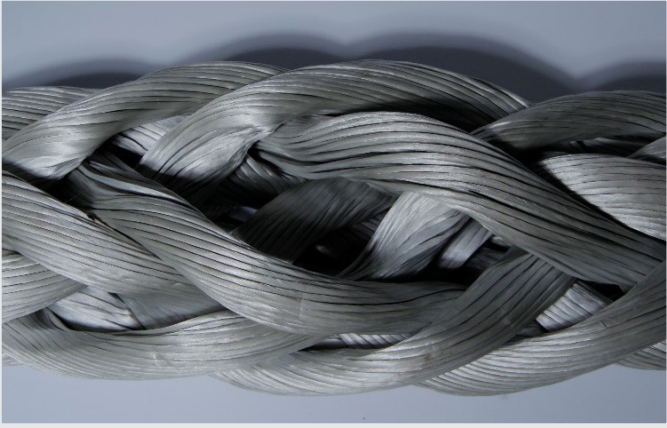
Green	Fibers intact, no visible external damage.

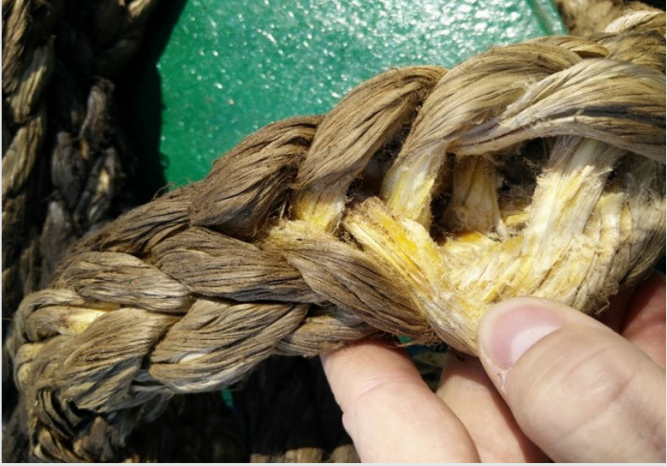
Yellow	Minor visible internal abrasion. Some broken filaments. Recommend monitoring and inspecting the rope.

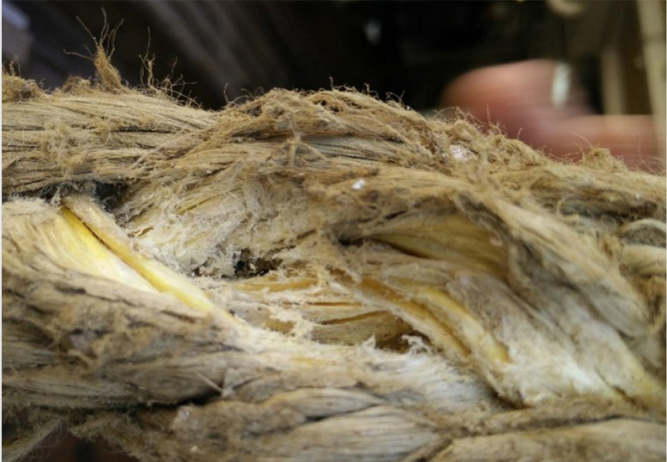
Red	Internal abrasion clearly visible. Broken and powdered filaments in the center of the rope. Rope must be retired.

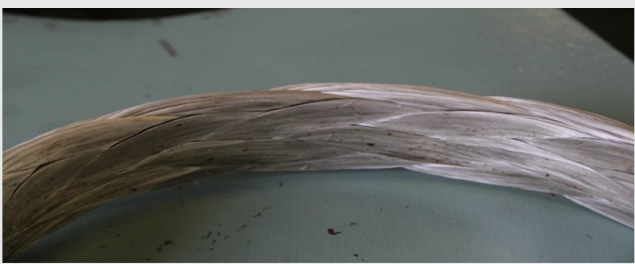
<p>Glazed appearance, it is possible to recover the original shape of the rope by flexible bending and further use under tension. Monitor and inspect the rope regularly, investigate the root cause and do corrective actions. Recommend protecting the rope.</p>

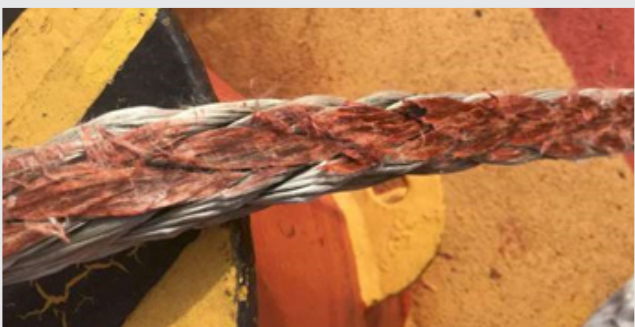
<p>Glazed appearance due to heat build-up and melted fibers. Fibers damaged and non-recoverable flattening. Rope must be retired.</p>

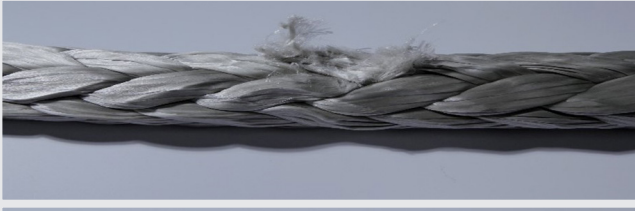
Visible cut in fibers. Less than 3% of total amount of yarns. Recommend monitoring the rope, inspect and find sharp edge in the path of the rope causing the cut and repair. Protect the rope.

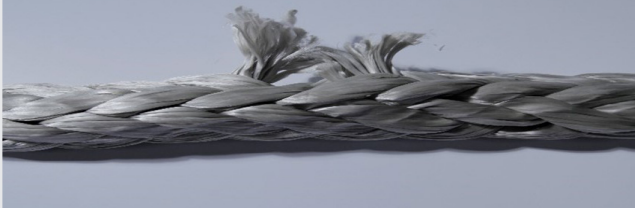
Cut yarns clearly visible on more than 3% of total amount of yarns in whole rope. Rope must be retired. Inspect and find sharp edge in the path of the rope causing the cut and repair. Protect the new rope.

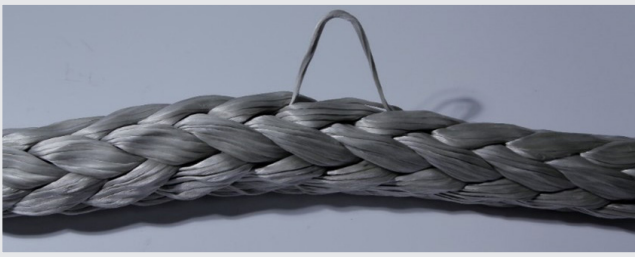
Minor damage. Hide the fibers inside the rope. Inspect and find the obstacle causing the pulled yarns and remove or repair.

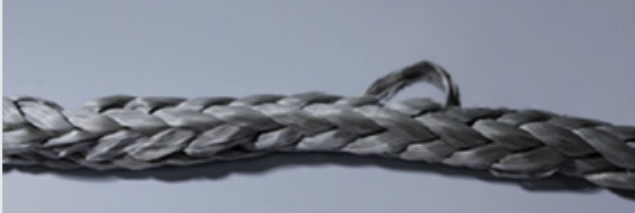
Pulled strand can be repaired by working the strand into the rope by locating the damage on the length of the rope and by pulling and settling the strand. Inspect and find the obstacle causing the pulled strand and remove or repair.

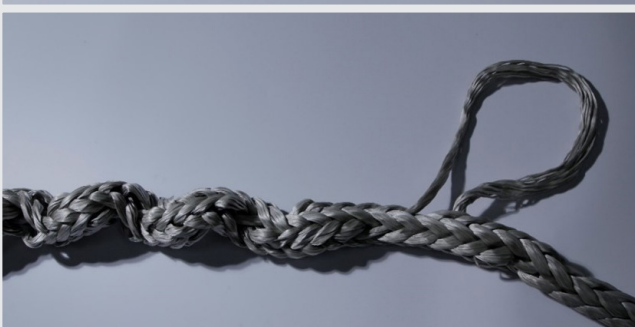
Pulled strand caused major constructional damage on rope's length. Ropes must be retired. Inspect and find the obstacle causing the pulled strand and remove or repair.

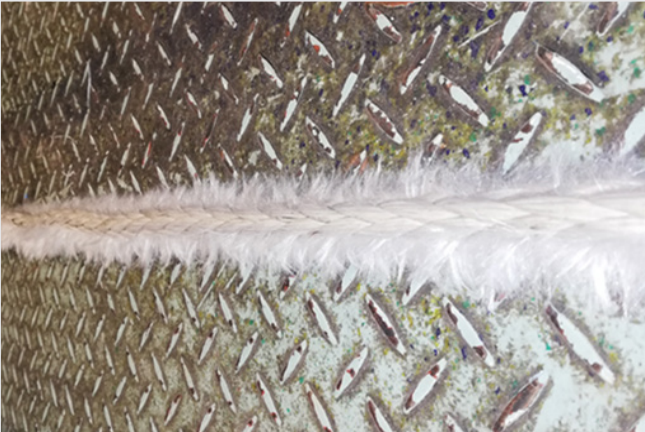
UV degradation on rope after tension is applied. Damaged fibers easily visible. The signs of UV degradation are not always visible before tension is applied. Attention must be paid to ropes that have been exposed to sunlight over an extensive period of time. Rope must be retired.

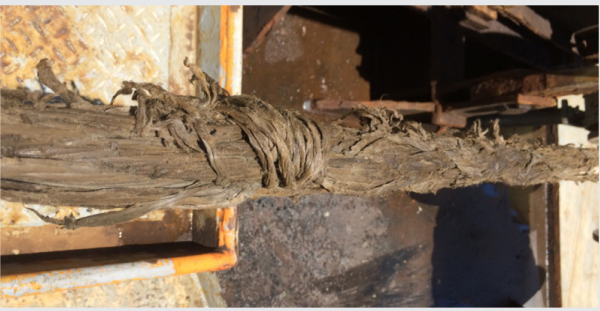
Rope log shows that there has been significant exposure to chemicals. Rope must be retired.

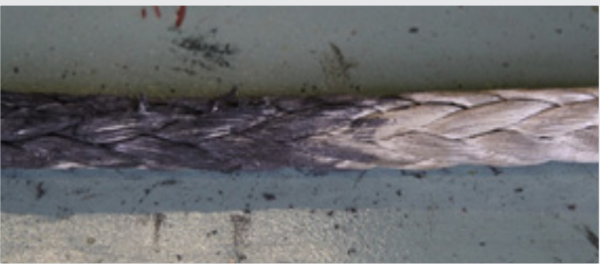
Rope discoloration, brittle fibers, fusion, bonding of fibers, hardness. Chemical exposure suspected. Rope must be retired.

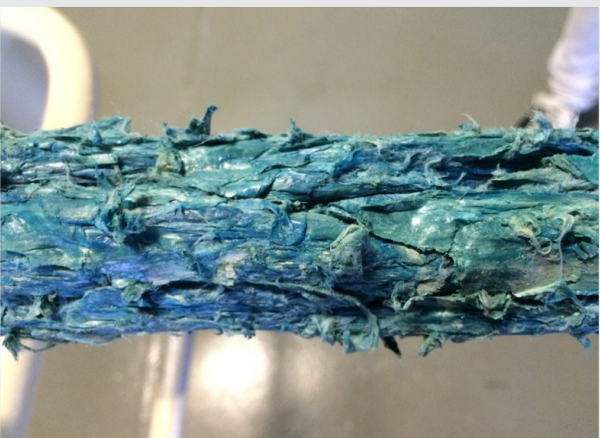
Known significant exposure to high temperature. Melted and/or discoloration.

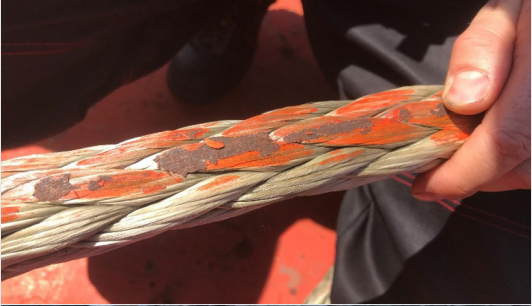
<p>Rope and deck/floor dirty and hardware paint dried on the rope. Recommended to inspect regularly for internal and external abrasion.</p>

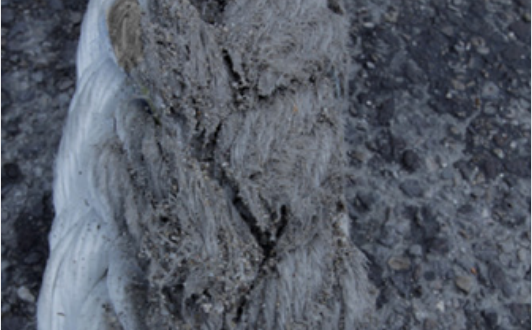
<p>Dirt in the rope structure, broken fibers. Internal and external abrasion. Rope must be retired.</p>
