# Mooring Ropes Inspection & Retirement Guidelines—Timm Acera Amundsen

# 2. Product Properties

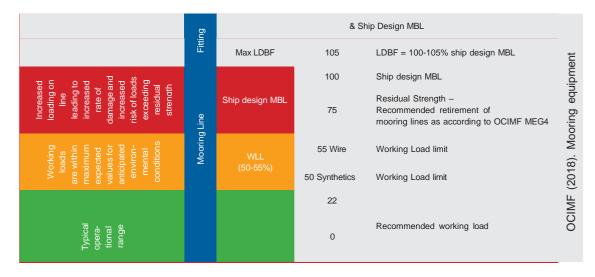
According to OCIMF MEG4, the typical operating range of the rope is up to 22% of the Ship design MBL. The working load limit is 50% for synthetic ropes. Loads higher than this limit will cause damage on the rope, decrease the lifespan of the rope, and cause a risk or rope's breakage by exceeding the residual strength.

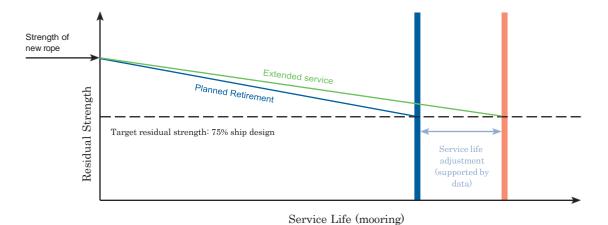
For more individual retirement criteria we recommend performing a test of residual strwwength as mentioned by OCIMF MEG4. By performing a test and gradually building up historical data on different ropes and tails, the vessel will create the optimal solution. In addition to that, regular inspection with certain intervals should be performed and ropes and tails discarded if deemed necessary.

Service life adjustment according to OCIMF MEG4

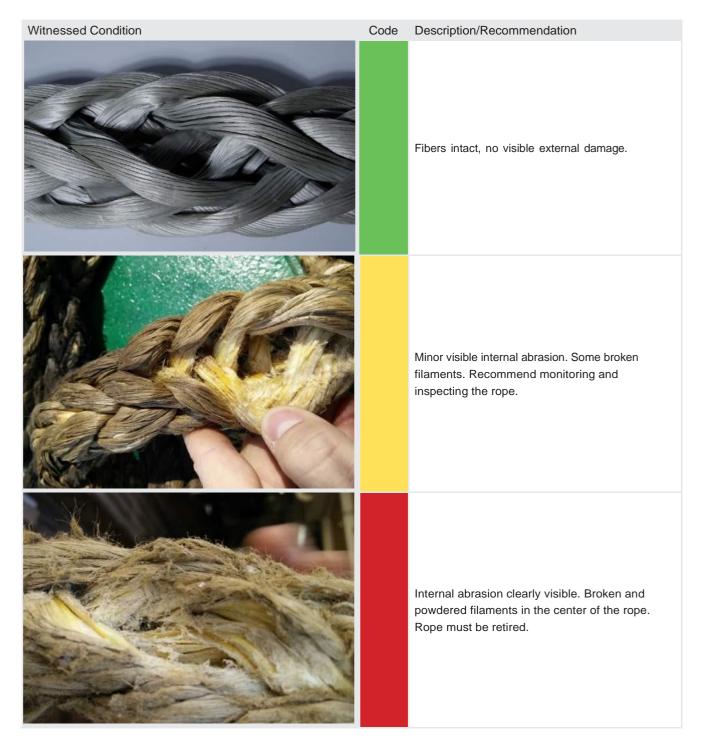
#### 3.3 Internal Abrasion

If ropes are cycled for extended periods of time, even within a normal working load range, they will gradually loose strength. There are various mechanisms for the breakdown of synthetic fibers under cyclic tension, however the most common is fiber on fiber abrasion.

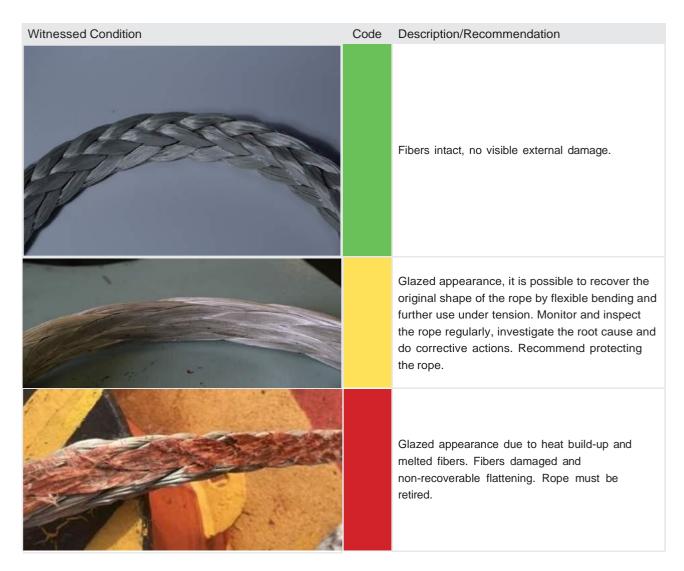
#### 3.4 Bending Fatigue

Constant bending of any type of rope will cause internal and external fiber abrasion and is frequently caused by running on pulleys. Other types of flexing, such as frequent bending over a small radius surface may also cause fatigue damage to the ropes. Flexing over fixed surfaces is often accompanied by surface wear, if sliding action is present as well. Wear will appear on the surface of the contact area. The fibers will become matted on the surface and/or glazed form heat buildup. Broken and melted filaments will be found inside the rope over the bending zone but not elsewhere.

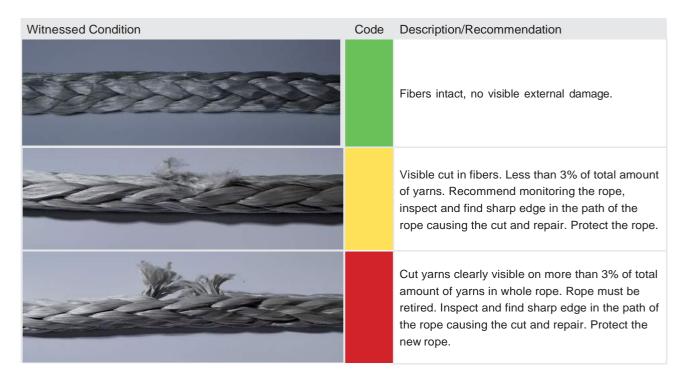
#### 3.5 Cuts

Cuts in fibers and strands are usually a sign of contact between rope and any sharp edges. If one or more strands are cut, it is necessary to remove the affected area and resplice new eye if possible. The level of damage is a function of the percentage of the rope cross-section that has been permanently lost.

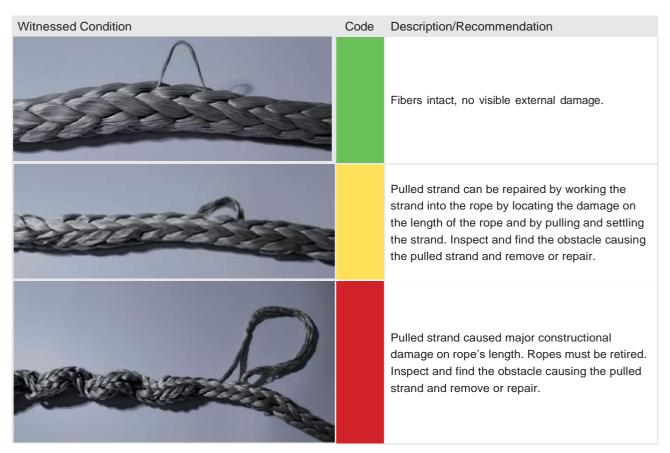
#### 3.6 Pulled Strands and Yarns

If yarns or strands get stuck on equipment or obstacles, these yarns or strands can be pulled out. Pulled yarns or strand can easily be put back into the rope.

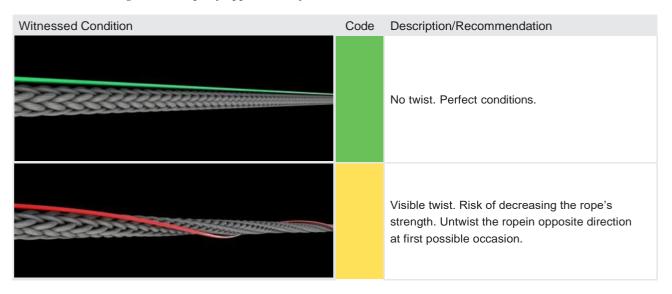
#### 3.7 Twist

Braided and plaited ropes should display little or no twist. If there is a twist in the rope, be aware that one twist per meter will decrease the strength of the rope by approximately 6%.

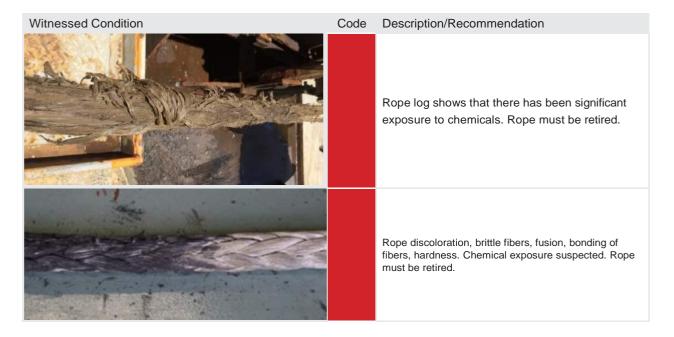
Synthetic fibers generally have good resistance towards chemical attack and heat exposure under normal circumstances but may be weakened in certain situations. In many cases visual inspection may reveal discoloration and brittleness of the fibers. Melting, bonding of fibers, hard spots or stickiness may be observed, yet these indications are not always present. Any exposure to chemicals shall be logged and the inspector should research the exposure history of the rope.

Nylon ropes can be seriously degraded by long-term contamination with rust when wet. This can be detected by a reddish or brown coloration. Fiber ropes stored at even moderately high temperatures for long periods of time can be degraded without visual indication.

High temperature will reduce the tenacity of the rope. The effect is greater at high humidity. Therefore, nylon ropes/tails used in a high temperature / high humidity environment will degrade faster.

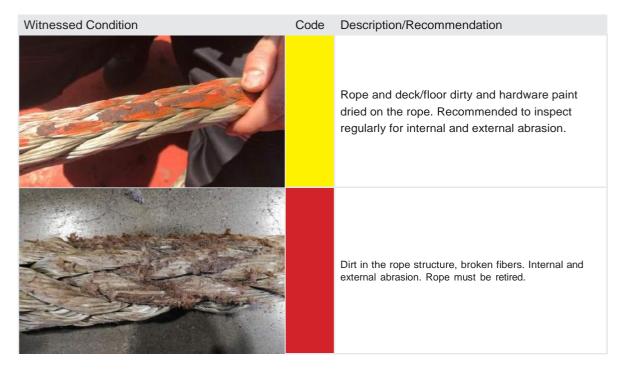
#### 3.11 Dirt and Particles

Contamination with dirt particles can cause internal fiber abrasion in ropes.

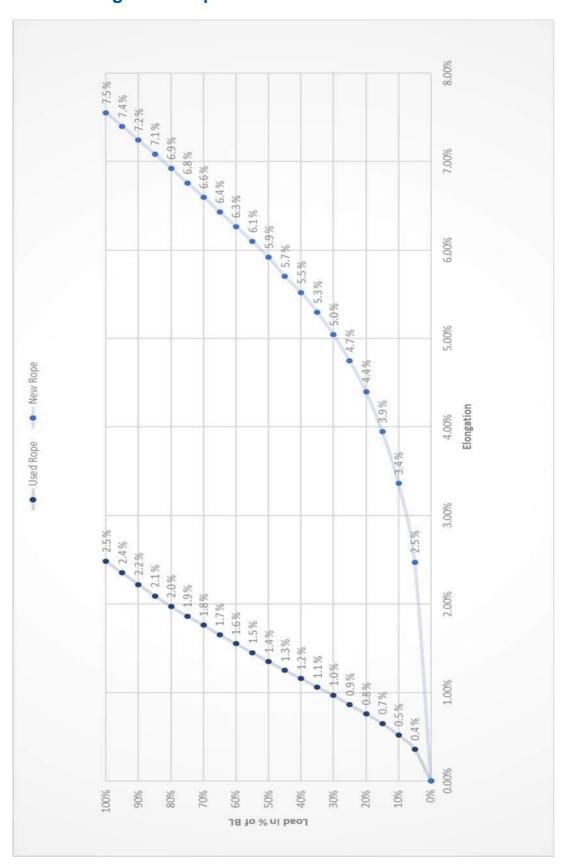
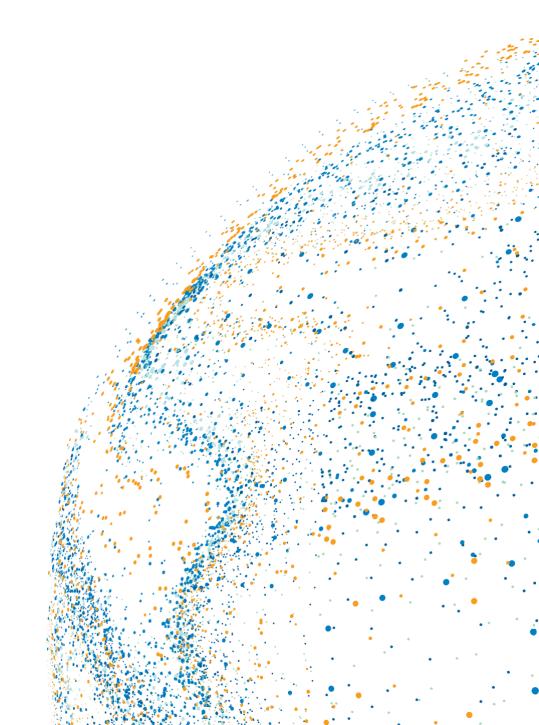
# Appendix A – Elongation Graphs

Refer to Appendix A for more information on the elongation of Acera ropes.
