# Mooring Tails Inspection & Retirement Guidelines

# 1. Introduction

### 3. Tail condition evaluation

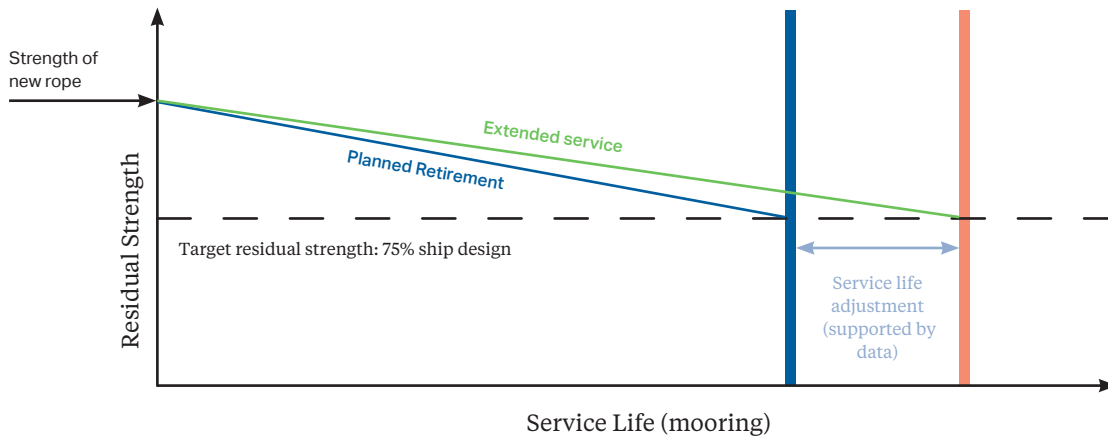
Service life adjustment according to OCIMF MEG4

OCIMF MEG4 recommends retiring mooring ropes/tails, when the residual strength has reached 75% of the Ship Design MBL. Today this can only be determined by a destructive test.

For more individual retirement criteria we recommend performing a test of residual strength as mentioned by OCIMF MEG4. By performing a test and gradually building up historical data on different ropes and tails, the vessel will create the optimal solution. In addition to that, regular inspection with certain intervals should be performed and ropes and tails discarded if deemed necessary.

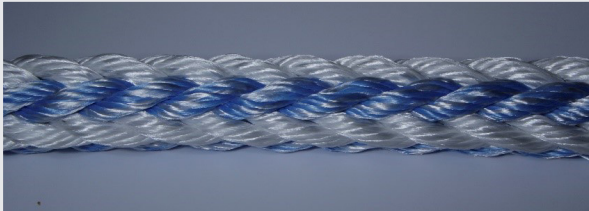
Fibers intact, no visible cuts.

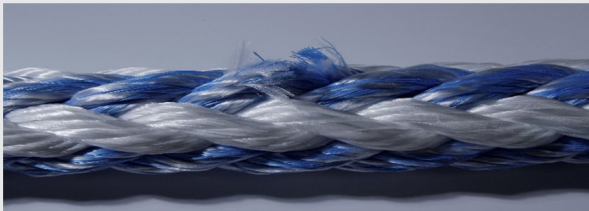
Visible cut in fibers. Visible cuts in very few yarns is acceptable, however monitoring the tail is recommended. Inspect and find sharp edge in the path of the tail causing the cut and repair. Protect the rope.

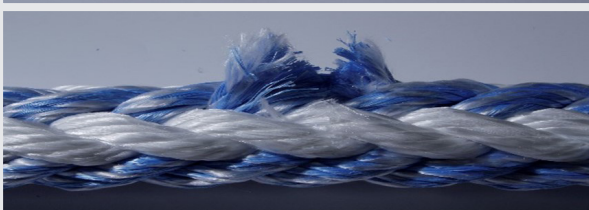
Cut yarns clearly visible on several yarns in the rope. Tail must be retired. Inspect and find sharp edge in the path of the rope causing the cut and repair the area. Protect the new rope.

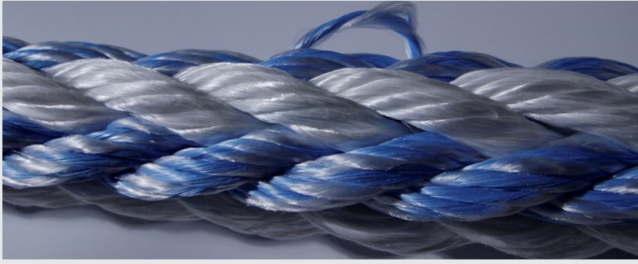
Minor damage. Hide the fibers inside the rope. Inspect and find the obstacle causing the pulled yarns and remove or repair.

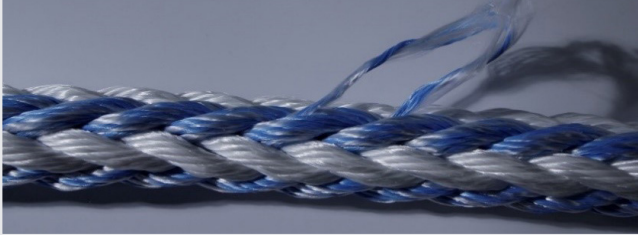
Pulled yarns can be repaired by working the yarns into the tail or cutting off close to the rope surface. Inspect and find the obstacle causing the pulled yarns and remove or repair.

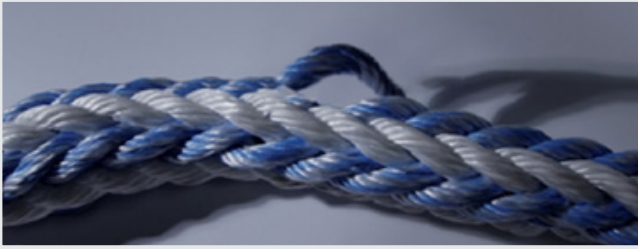
Pulled strand can be repaired by working the strand into the rope by locating the damage on the length of the tail and by pulling and settling the strand. Inspect and find the obstacle causing the pulled strand and remove or repair.

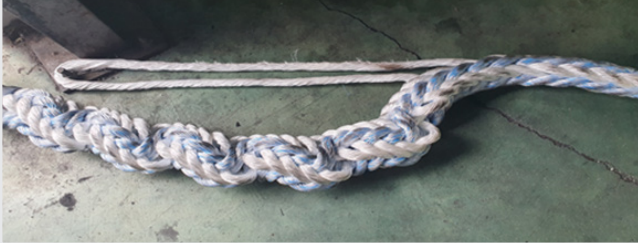
Pulled strand caused major constructional damage on tail's length. Tails must be retired. Inspect and find the obstacle causing the pulled strand and remove or repair.

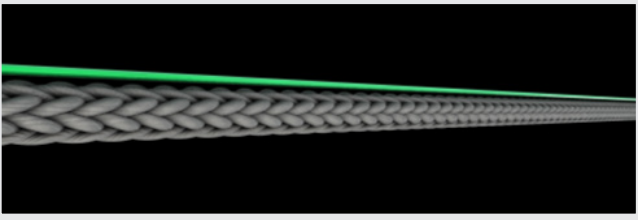
No twist. Perfect conditions.

Tails should display little or no twist. If there are twists in the tail, be aware that one twist per meter will decrease the strength of the tail by approximately 6%.

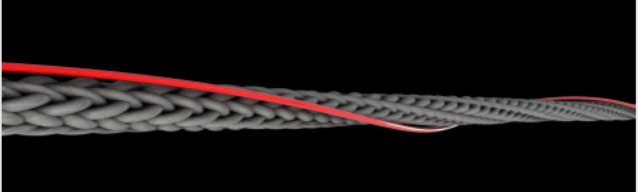
Visible twist. Risk of decreasing the tail's strength. Untwist the rope in opposite direction at first possible occasion.

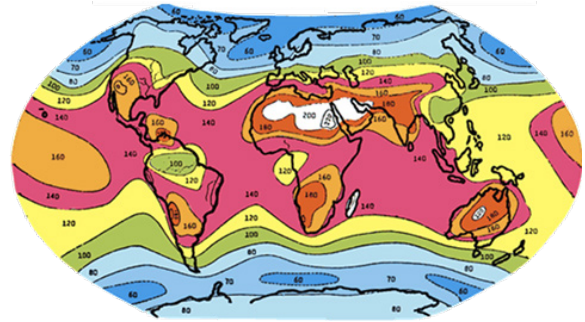
Generalized Isolines of Global Radiation (Kcal./cm<sup>2</sup>/year) expressed in Kilo-Langley per year By H.E. Landsberg

Ultra-violet (UV) radiation from direct sunlight will cause brittle, weak outer yarns on the tail and start destruction process in inner yarns. UV degradation is difficult to inspect visually, however brittleness and discoloration may be observed in some cases. For a definitive assessment, strength testing of a few surface fibers or in some cases the entire tail is required. In some cases, the filaments can be crushed by hand due to brittleness. Some improperly stored tails could seem to be in good condition, but UV damage will be easily visible under tension.

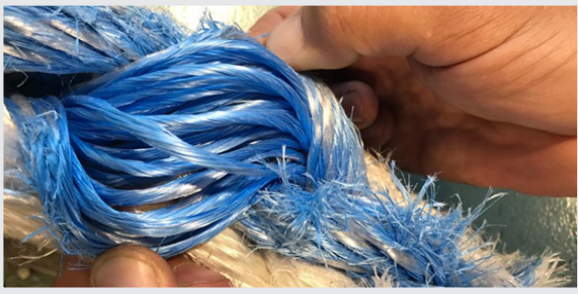
UV degradations visible by crushed fibers. Tail must be retired.

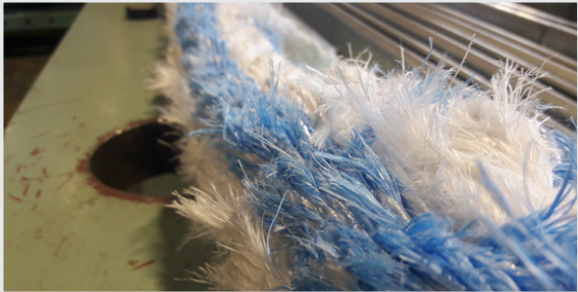
UV degradations visible by crushed fibers. Tail must be retired.

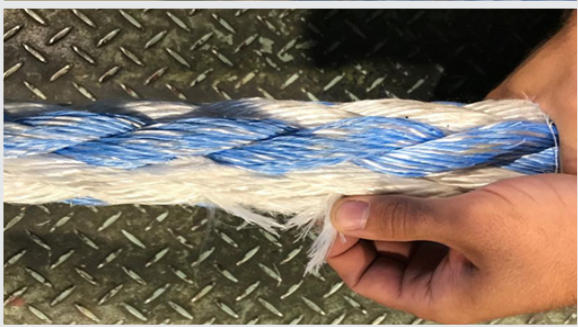
Yarns easily crushed or damaged by hand. Tail must be retired.

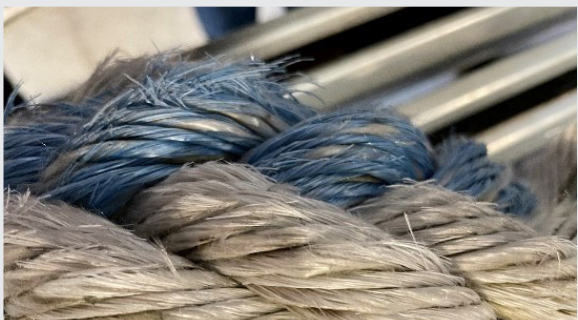
UV degradation on tail after tension is applied. Damaged fibers easily visible. The signs of UV degradation are not always visible before tension is applied. Attention must be paid to ropes that have been exposed to sunlight over an extensive period of time. Tail must be retired.

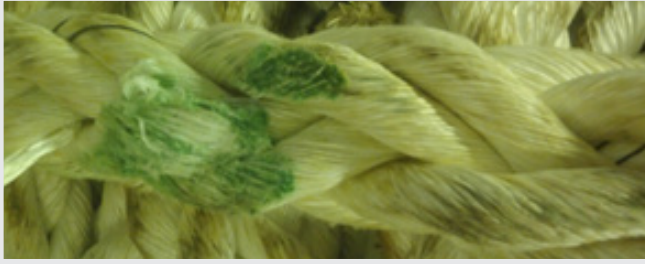
Tail log shows that there has been significant exposure to chemicals. Tail must be retired.

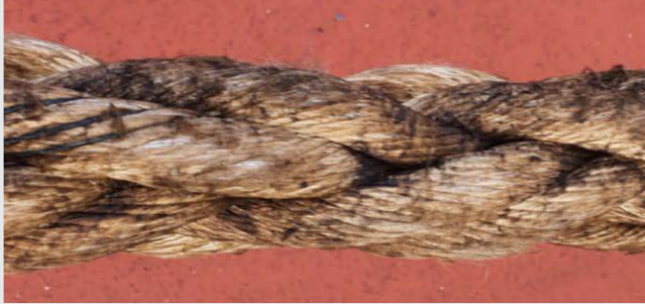
Tail discoloration, brittle fibers, fusion, bonding of fibers, hardness. Chemical exposure suspected. Tail must be retired.

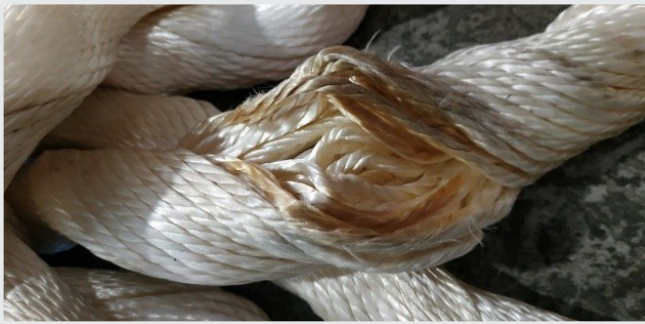
Tail log shows that there has been significant exposure to chemicals. Tail must be retired.

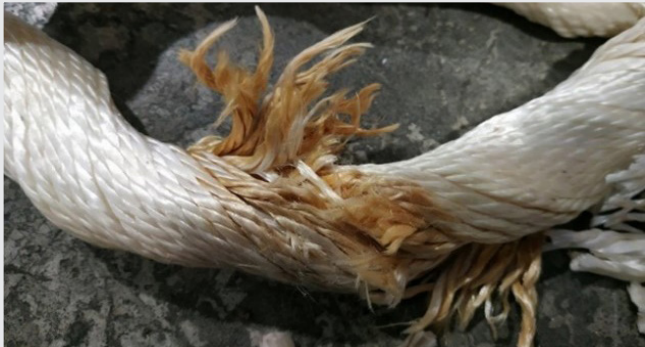
Tail discoloration, brittle fibers, fusion, bonding of fibers, hardness. Chemical exposure suspected. Tail must be retired.

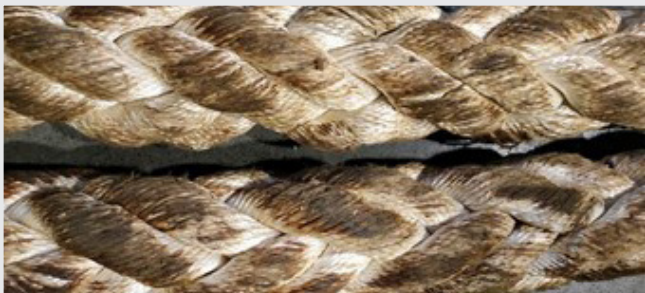
Nylon tail has been used or stored when wet in contact with oil. Tail must be tested or retired.

Nylon tails can be seriously degraded by long-term contamination with rust when wet. This can be detected by a reddish or brown coloration.

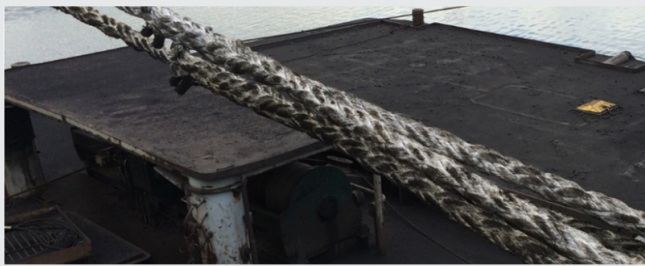
<p>Tail and deck/floor dirty. Recommended to inspect regularly for internal and external abrasion.</p>

Contamination with dirt and particles can cause internal fiber abrasion in ropes.

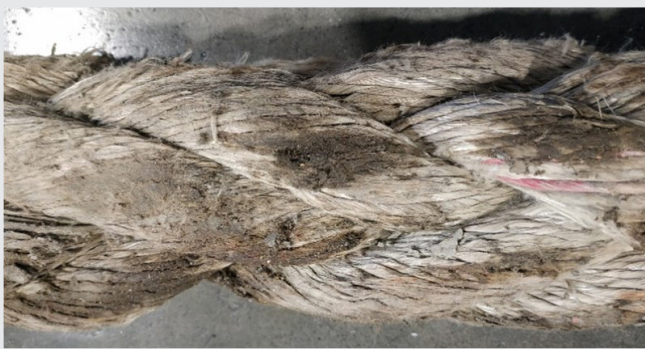
<p>Tail discoloration, brittle fibers, fusion, bonding of fibers, hardness. Chemical exposure suspected. Tail must be retired.</p>
